148 High Road

1985 Townwide Historic and Architectural Survey of Berlin, Connecticut. Survey # 053

IDENTIFICATION		1. BUILDING NAME (Common)		(Historic)	
		1. BUILDING NAME (Common)		William Hooker House	
2. TOWN CITY		VILLAGE		COUNTY	
Berlin		Kensington		Hartford

William Hooker House

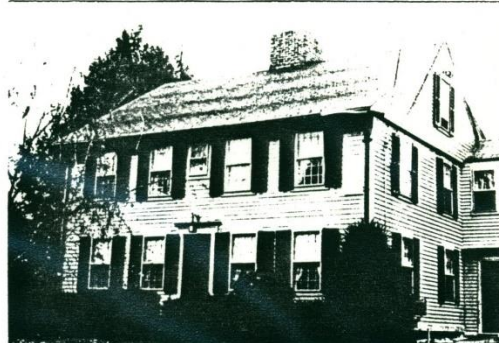
DESCRIPTION (Continued)	17. OTHER NOTABLE FEATURES OF BUILDING OR SITE (interior and/or exterior)	
	<p>The William Hooker House has a five-bay facade with a central entry. The entry has plain pilasters and a plain frieze with a simple molded cap and a heavy paneled door. Windows have wide, plain-board surrounds and are fitted with old 12-over-12 sash and modern storm sash. The house has plain corner boards and an overhang across the gable ends. Much exterior wall cladding is recent. To the right is a modern one-story garage addition.</p>	
SIGNIFICANCE	18. ARCHITECT	BUILDER

19. HISTORICAL OR ARCHITECTURAL IMPORTANCE	
<p>Despite the presence of a considerable amount of new exterior fabric, the William Hooker House is significant as a good surviving example of an 18th-century central chimney house. An adaptation of traditional English building techniques to a harsh climate rich in stone, timber, and firewood, the central chimney house was the predominant domestic building type in 18th-century New England. The large central chimney, generally constructed of stone below the roofline, functioned as an enormous thermal mass. Once warmed, its tons of rock could store and release heat for hours. It remained popular in relatively isolated areas such as Berlin until after 1800. Typical 18th-century features include the symmetrical five-bay facade, the ridge-parallel orientation, small-pane sash, and hewn overhang. The Hooker family built a number of houses in this section of Berlin; this dwelling was (continued)</p>

built by William Hooker in 1771. In its early years it served as an inn. The entry is more formal than is typical for late-18th-century houses in Berlin, with its pilasters and molded cap. The house's public function--an inn--probably accounts for the use of detailing usually associated with more fully realized examples of Georgian architecture.
